Manhole Inspection Summary

Manhole # S31WW_011MH

Location Address: **3100 WYAMN PARK DR**

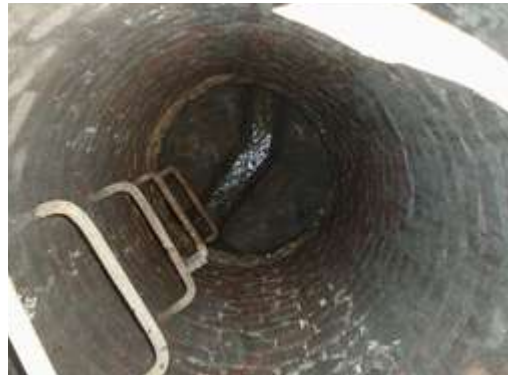
Top View

Steps Count: **5** Missing: **0** ☒ **Corroded**

Surcharge ☒ **Evidence Of Surcharge** Depth: **1.5** (ft.) ☐ Active Surcharge Present

Corroded steps. Evidence of surcharge - Bench debris.

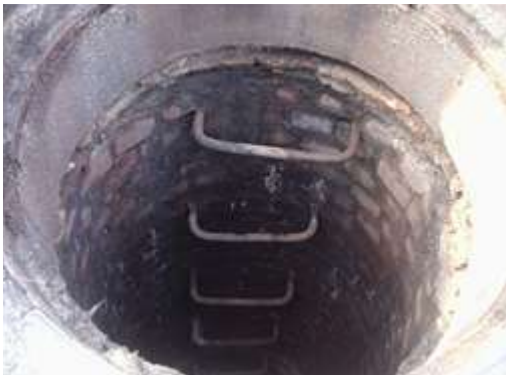
Defect

Frame Offset: **0** (in.) Condition: ☐ Sound ☐ Cracked ☒ **Leaks**

Condition: ☐ Sound ☐ Cracked ☐ Root Intrusion ☐ Loose Brick ☒ **Deteriorated**

Infiltration: ☐ None ☒ **Joint** ☐ Cracks ☐ Mortar ☐ Roots ☒ **Wall**

Infiltration: ☐ None ☐ Joint ☐ Cracks ☐ Mortar ☐ Roots ☒ **Wall**

Frame leaks. Adjustment deterioration and infiltration. Corbel infiltration - other side.

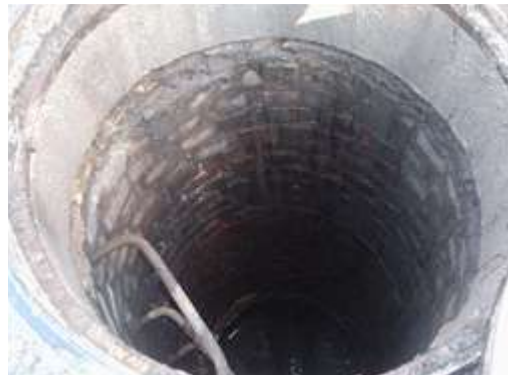
Defect

Frame leaks. Adjustment deterioration and infiltration. Corbel infiltration.
